REPORT OF MARINE SURVEY  
OF THE VESSEL  
*Sara B*

April 27, 2018

LOA 47ft. Tancook-Style Schooner

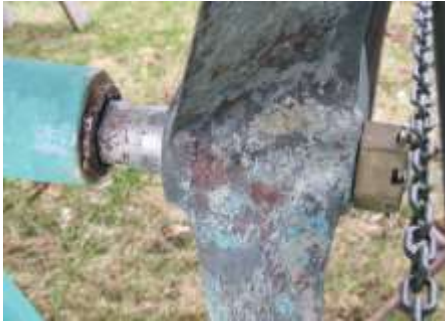
RUDDER MATERIAL	Steel – Appears sound
THROUGH HULL FITTINGS	Bronze – Appear serviceable
ZINCS	On Rudder - Serviceable
CONDITION OF BOTTOM PAINT	In process of being re-painted
KEEL	External Ballast
PROP SHAFT	1¼in. Stainless
CUTLASS BEARING	Some play <b>*C3</b>
PROP	18 x 13.5 3-bladed Bronze

**C3 The cutlass bearing has a little play.**  
*I recommend monitoring for a future repair.*

**Minor Play in Cutlass Bearing**

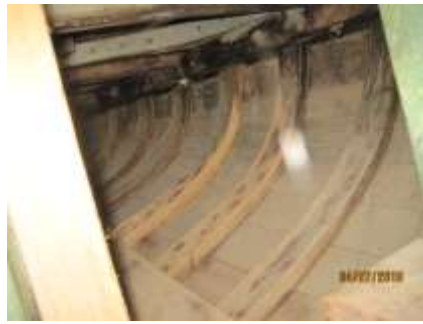
**Framing in Port Quarter**

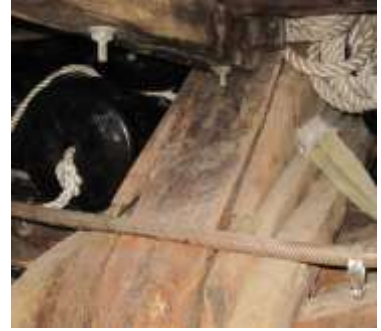
**Horn Timber**

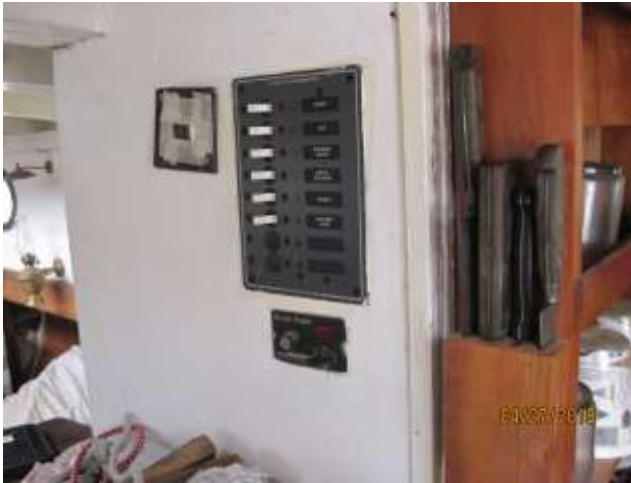
**12V Panel**

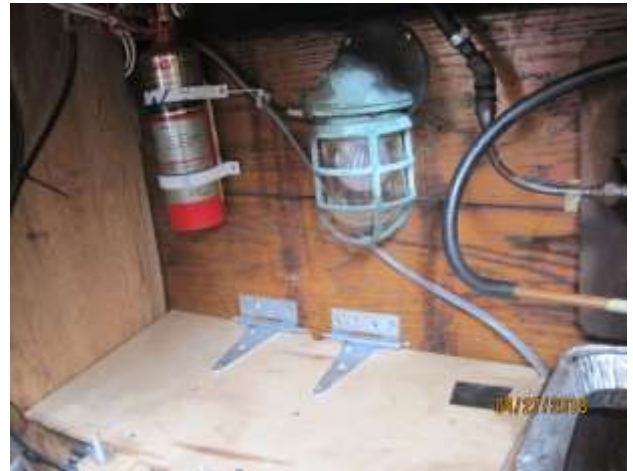
**Fire Suppression System**

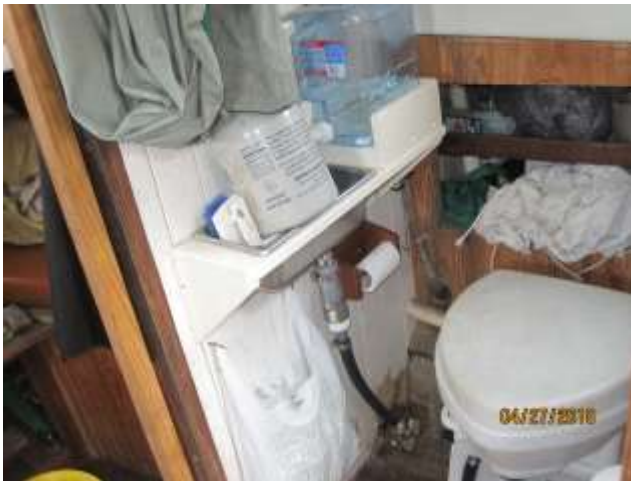
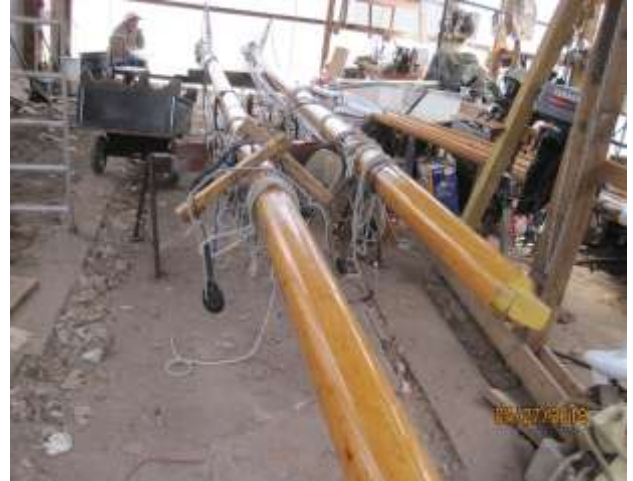
**Standing Rigging inspected off-site**
